**FIRST FIVE-YEAR REVIEW REPORT
FOR
CHEMICAL RECOVERY SYSTEMS SUPERFUND SITE
LORAIN COUNTY, OHIO**

**U.S. Environmental Protection Agency
Region 5
Chicago, IL**

This is the first FYR for the Chemical Recovery Systems Superfund Alternative Site (site or CRS). The triggering action for this statutory review is the July 16, 2015 on-site construction start date of the Phase I remedial action at the site. The FYR has been prepared due to the fact that hazardous substances, pollutants, or contaminants remain at the site above levels that allow for unlimited use and unrestricted exposure (UU/UE).

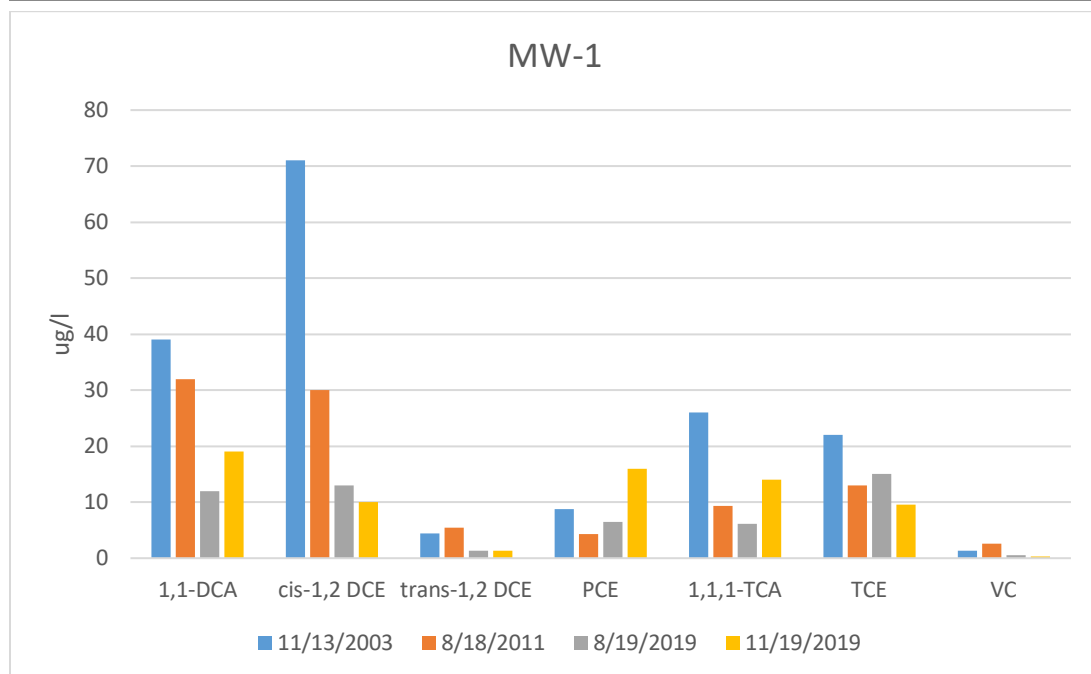
MW-1 – Distal plume northern sidegradient boundary, upper bedrock

MW-1	1,1-DCA	cis-1,2 DCE	trans-1,2 DCE	PCE	1,1,1-TCA	TCE	VC
11/13/2003	39	71	4.4	8.8	26	22	1.3
8/18/2011	32	30	5.5	4.3	9.3	13	2.6
8/19/2019	12	13	1.3	6.5	6.1	15	0.59
11/19/2019	19	10	1.3	16	14	9.6	0.36

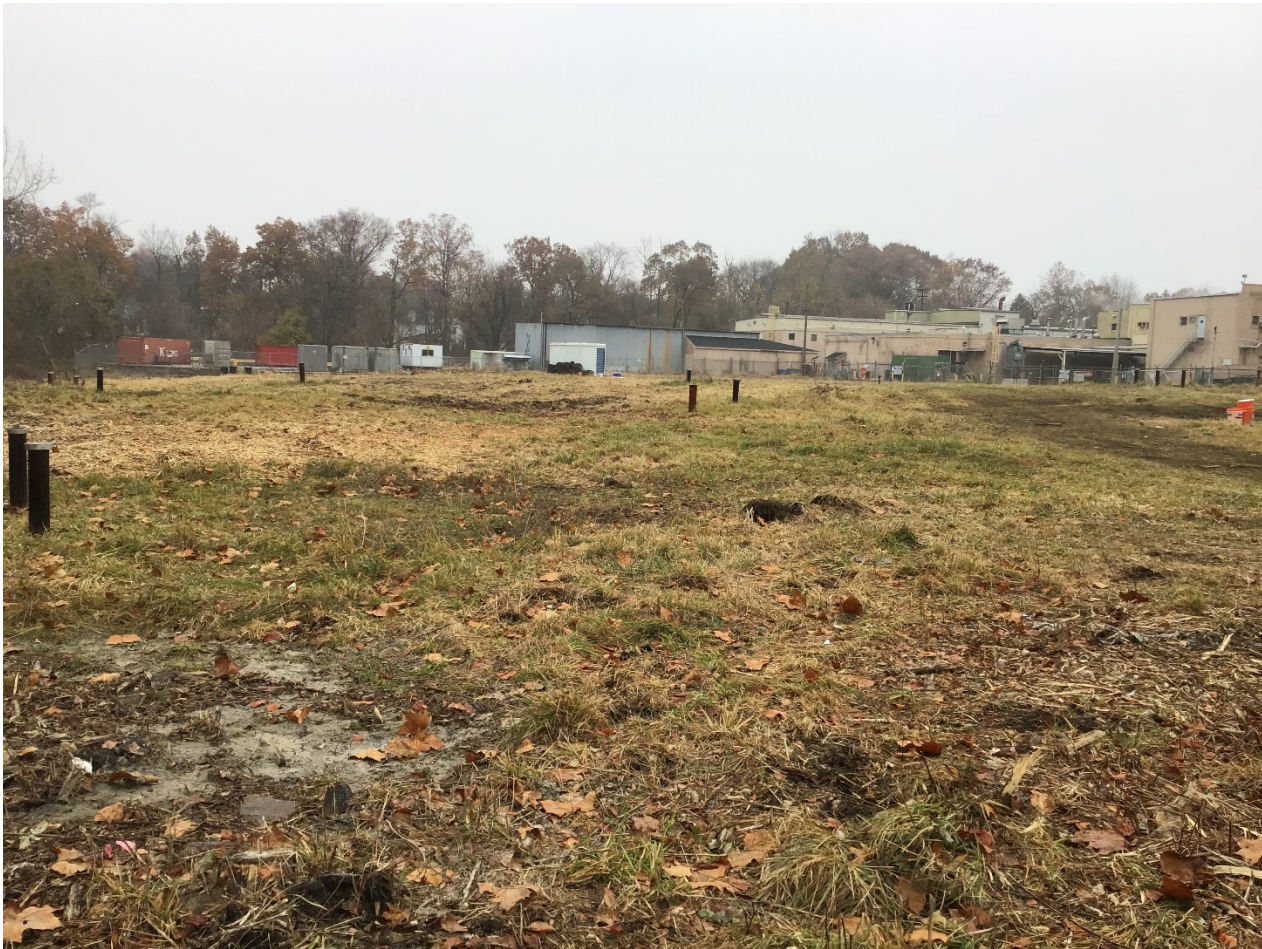
Approximately 80% of the site is shown in the following picture:

A substantial number of monitoring wells with intact outer casing are shown. The picture also shows that the buildings at the site have been demolished. The white building with a blue door near the center of the photograph is a small storage unit placed on the site to hold cores obtained from the bedrock investigation at the site. Former building foundations are overgrown with vegetation and are still present at the site along with various concrete slabs. Limited above-ground structures remain on the northern side of the site.

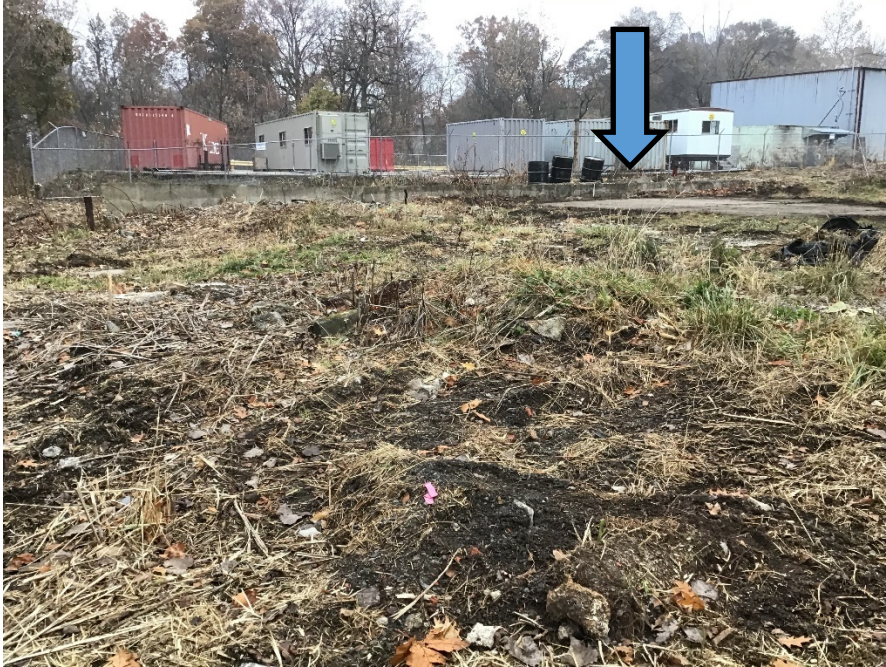
Picture of one of the concrete slabs remaining at the site that served as the foundation for the Brighton Still Building:

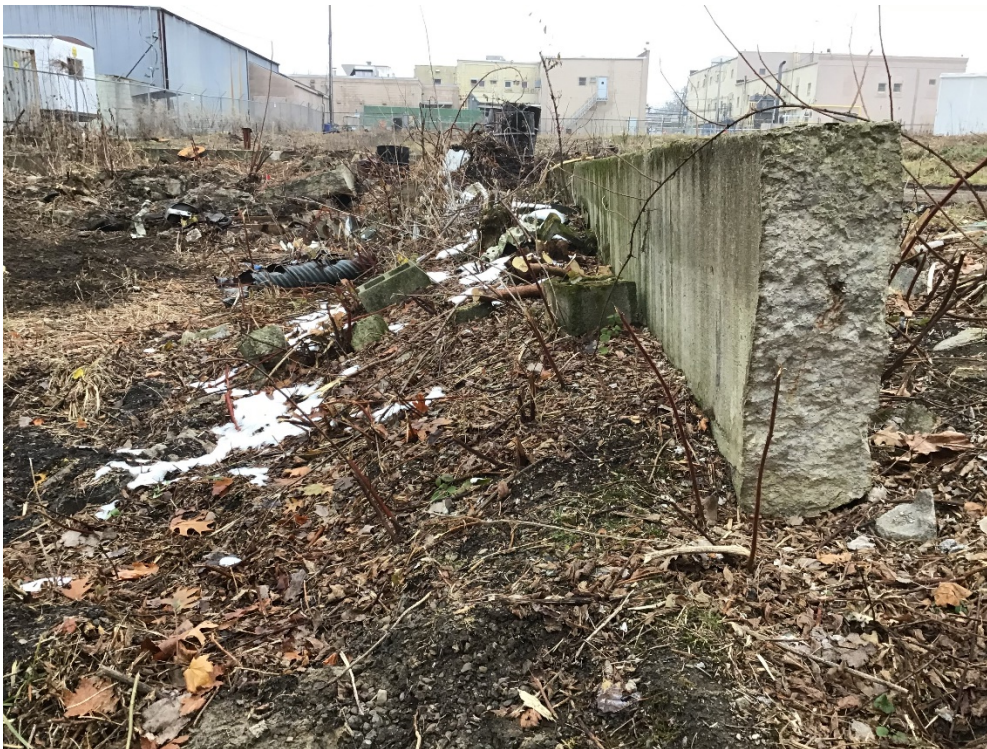
Picture of residual above-ground structures at the site other than the storage unit:

The portion of the Remedial Action (RA) that has been completed at the site so far includes building demolition and filling of two sumps with concrete. Soil proposed for removal in the RA Workplan remains at the site including contaminated surface soil. As the previous pictures show, debris is

currently present at the site that could present a trip hazard in the area where contaminated surface soil is present. The plugging and filling of the sewer line has not occurred. Other options are being considered for the sewer line. Quarterly groundwater monitoring began at the site in the summer of 2019 in order to assess current water quality trends.

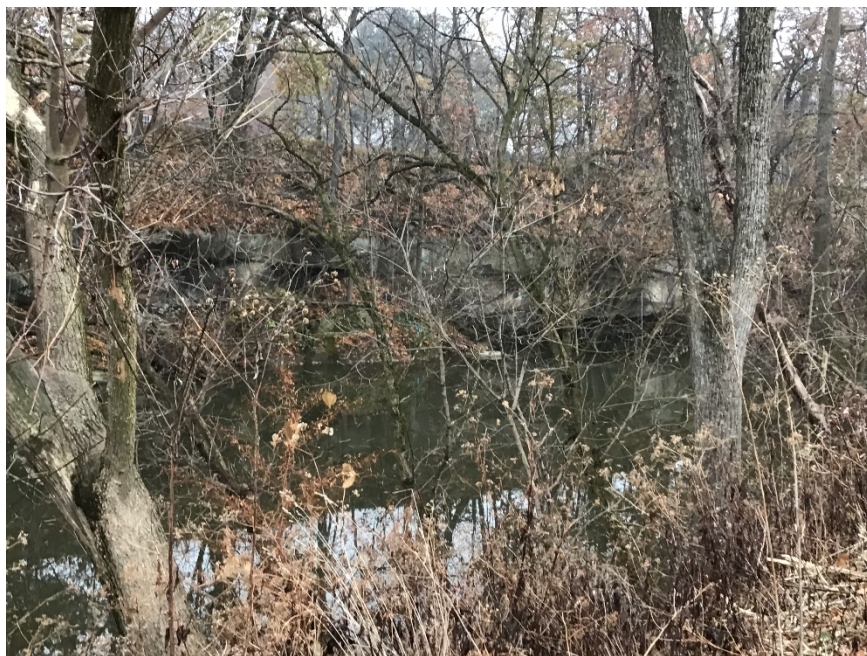
Site fencing is present on three sides of the property but is not present between the property boundary and the Black River. Where the fence is present, it does not have warning signs or no-trespassing signs to discourage site entry. The integrity of the fence is questionable in places where the fence is leaning. There is one area where the fencing is ingrown into a stump which would facilitate crossing the fence into the property by a trespasser. The PRPs indicate the fence has not been replaced as the plan was to replace it after soil removal was completed. To date, no signs of trespassing on the property have been noted.

With respect to the site fencing, it is present on three sides of the property but is not present between the property boundary and the Black River, as shown below:

OU(s): 1	Issue Category: Site Access/Security			
	Issue: No warning and/or notification signs on fencing at the site. Fencing is unstable and appears easy to circumvent.			
	Recommendation: Place a warning sign with a contact and phone number that advises the property is not to be entered due to the presence of contamination at the site. Shore up existing fencing until new fence is installed after construction.			
Affect Current Protectiveness	Affect Future Protectiveness	Party Responsible	Oversight Party	Milestone Date
No	Yes	PRP	EPA/State	7/31/2021

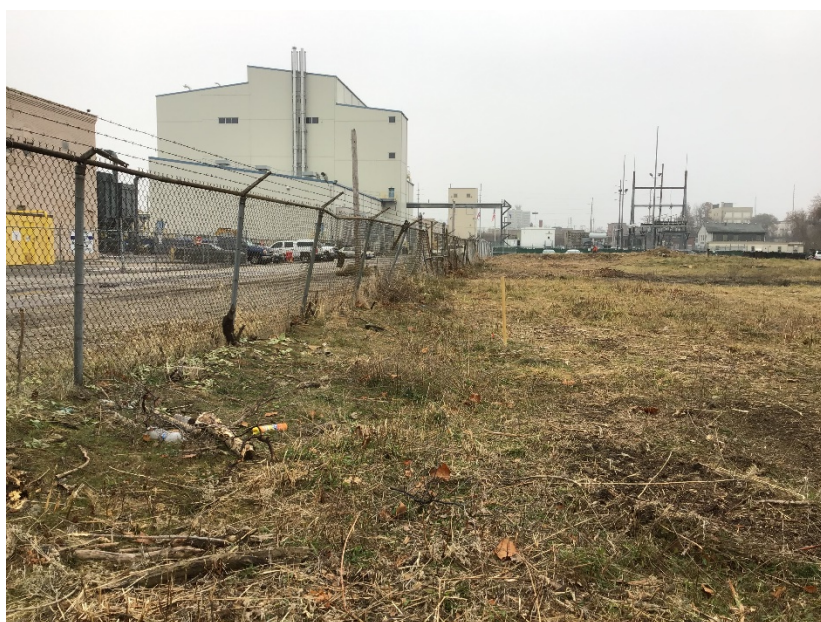
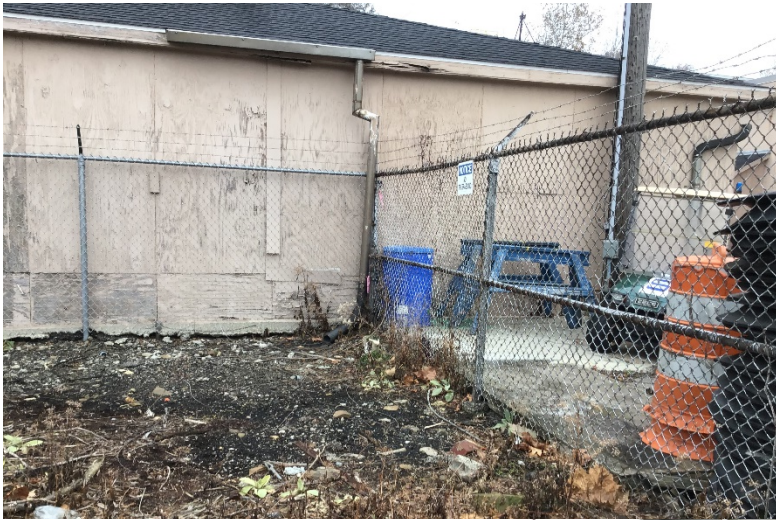
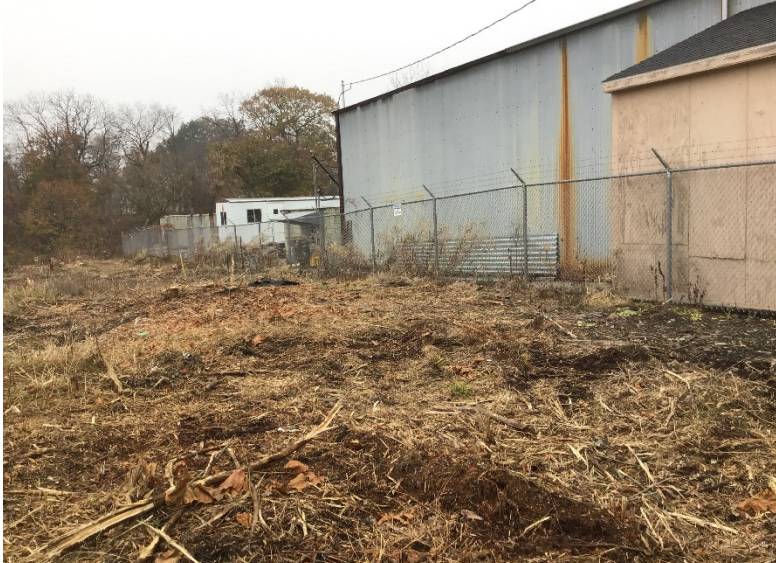
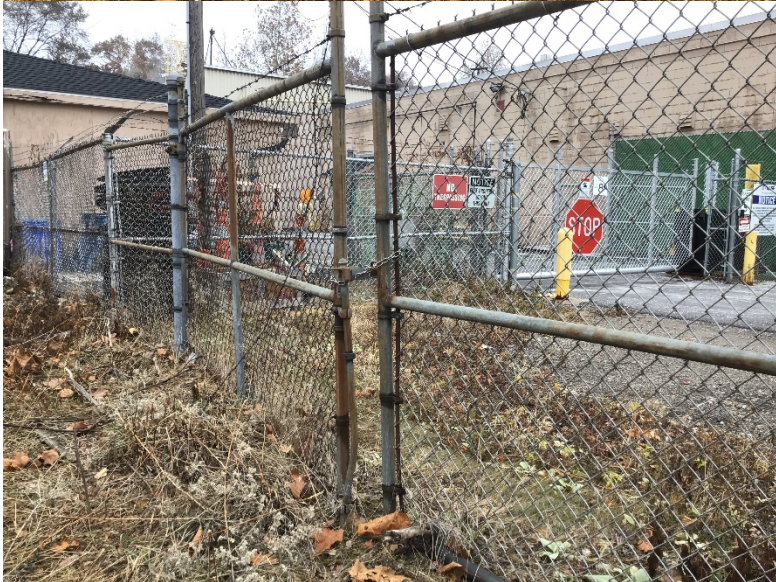
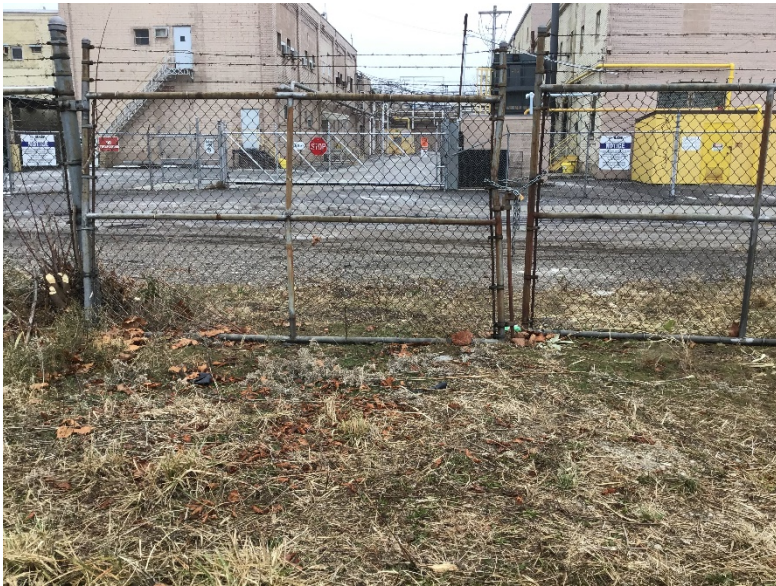
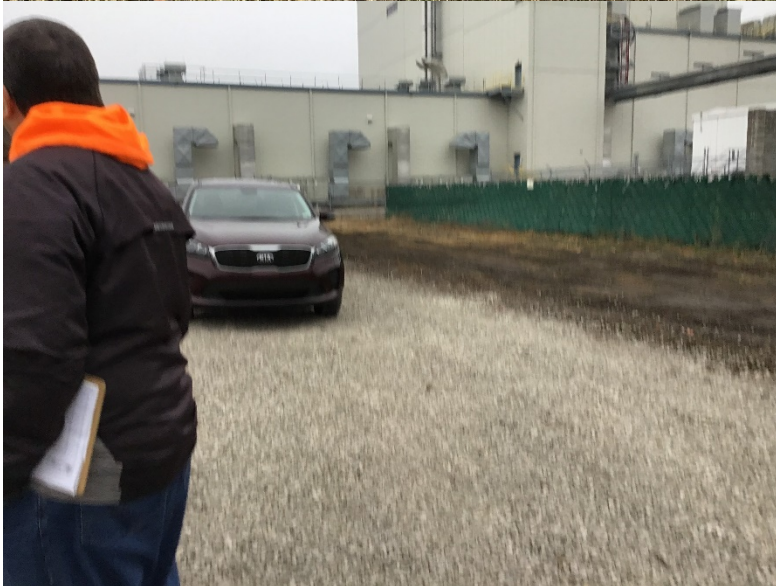
The photographs below show that where the fence was present, it did not have warning signs or no trespassing signs to discourage site entry:

The beige colored buildings and associated stop signs and security gates are associated with the adjacent BASF facility.

- Access controls including fencing and signage are inadequate to prevent potential trespasser exposure to contamination in surface soil at the site. The fence should be repaired, and warning signs installed. While the 11/19/2019 site inspection noted the need for such repairs, evidence of trespassing was not observed. Plans are underway to address these fencing and signage issues by July 2021.

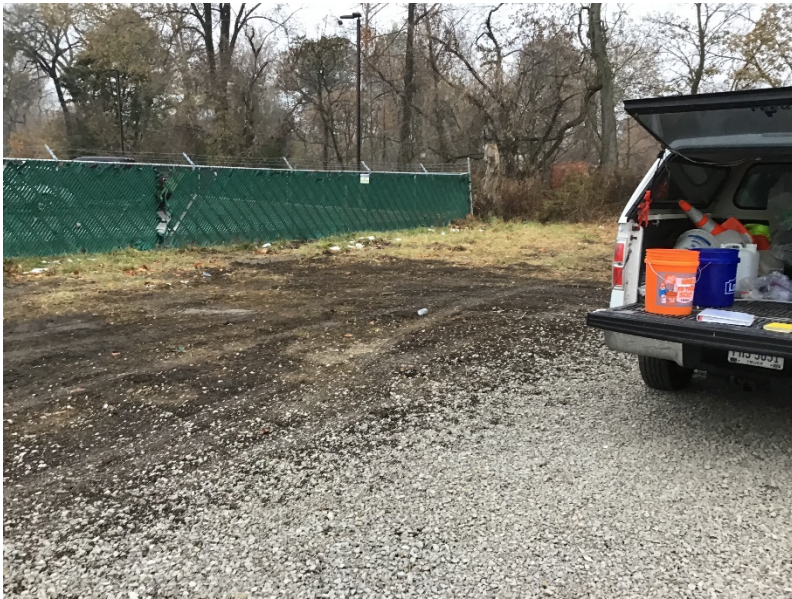
The picture above shows fencing on the southern side of the Chemical Recovery property. The fencing abruptly ends at the bank of the Black River. The small sign on the fencing shown above is a warning sign pertaining to the BASF property, and it appears the fence was installed by BASF.

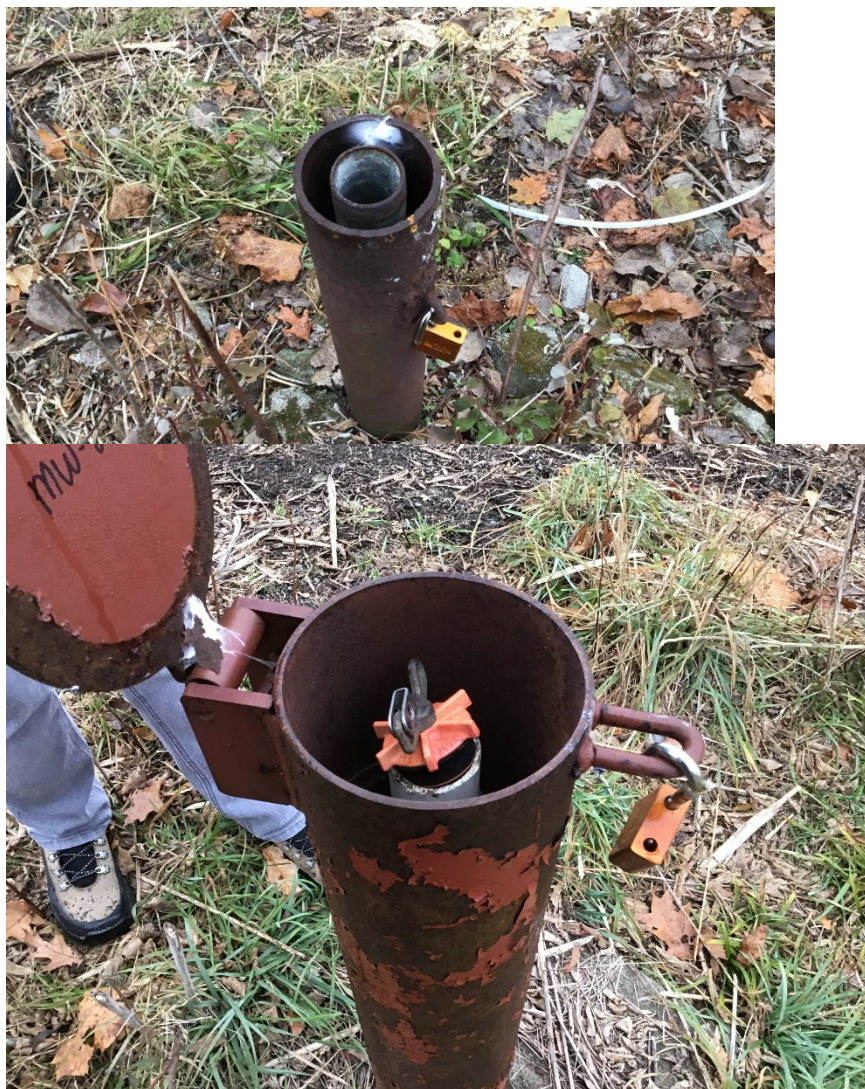
Quarterly groundwater monitoring began at the site in the summer of 2019 in order to assess current water quality trends. It was observed that the following wells did not have a plug or seal set into the inner casing: MW-1, MW-6RA, MW-6RB, MW-6RC, MW-8D, MW-11A, MW-11B, MW-11C, and MW-14. Absence of a plug in the well renders a question regarding well integrity and sample representativeness. The following wells had suitable outer casing and a seal on the inner casing: MW-5, MW-6, MW-7A, MW-7D, MW-10A, MW-10B, MW-10C, MW-15A, MW-15B, and MW-16. A copy of the Site Inspection Report is included in Appendix F.

With respect to the condition of the monitoring wells at the site, MW-3 and MW-4 were not able to be located, and they have been missing for an extended period of time. According to Pat Steerman, these wells were installed in the 1980s and were not included in the Remedial Investigation. It is not known if these wells were properly abandoned or destroyed. The remaining wells had outer casing and inner casing, but it was observed that the following wells did not have a plug or seal set into the inner casing: MW-1, MW-6RA, MW-6RB, MW-6RC, MW-8D, MW-11A, MW-11B, MW-11C, and MW-14. The following wells had suitable outer casing and a seal on the inner casing: MW-5, MW-6, MW-7A, MW-7D, MW-10A, MW-10B, MW-10C, MW-15A, MW-15B, and MW-16.

Pictures of a well with no plug and a well with a plug on the inner casing are shown below:

OU(s): 1	Issue Category: Monitoring			
	Issue: Monitoring well integrity may be compromised at: MW-1, MW-6RA, MW-6RB, MW-6RC, MW-8D, MW-11A, MW-11B, MW-11C, and MW-14.			
	Recommendation: Assess well integrity and upgrade well conditions for wells that remain useable. For wells with compromised integrity, replace the monitoring well.			
Affect Current Protectiveness	Affect Future Protectiveness	Party Responsible	Oversight Party	Milestone Date
No	Yes	PRP	EPA/State	12/31/2020

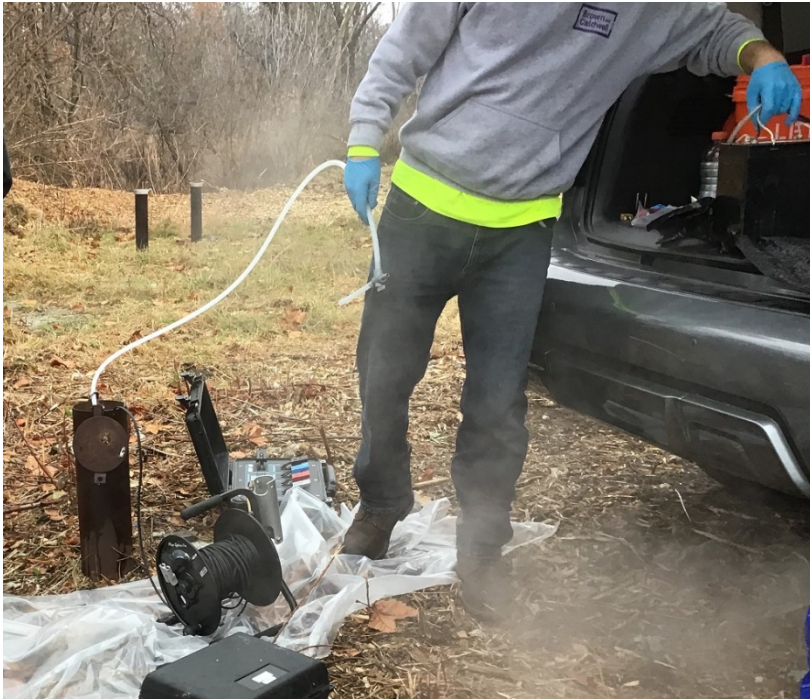
Sampling was ongoing during the site visit as shown below:

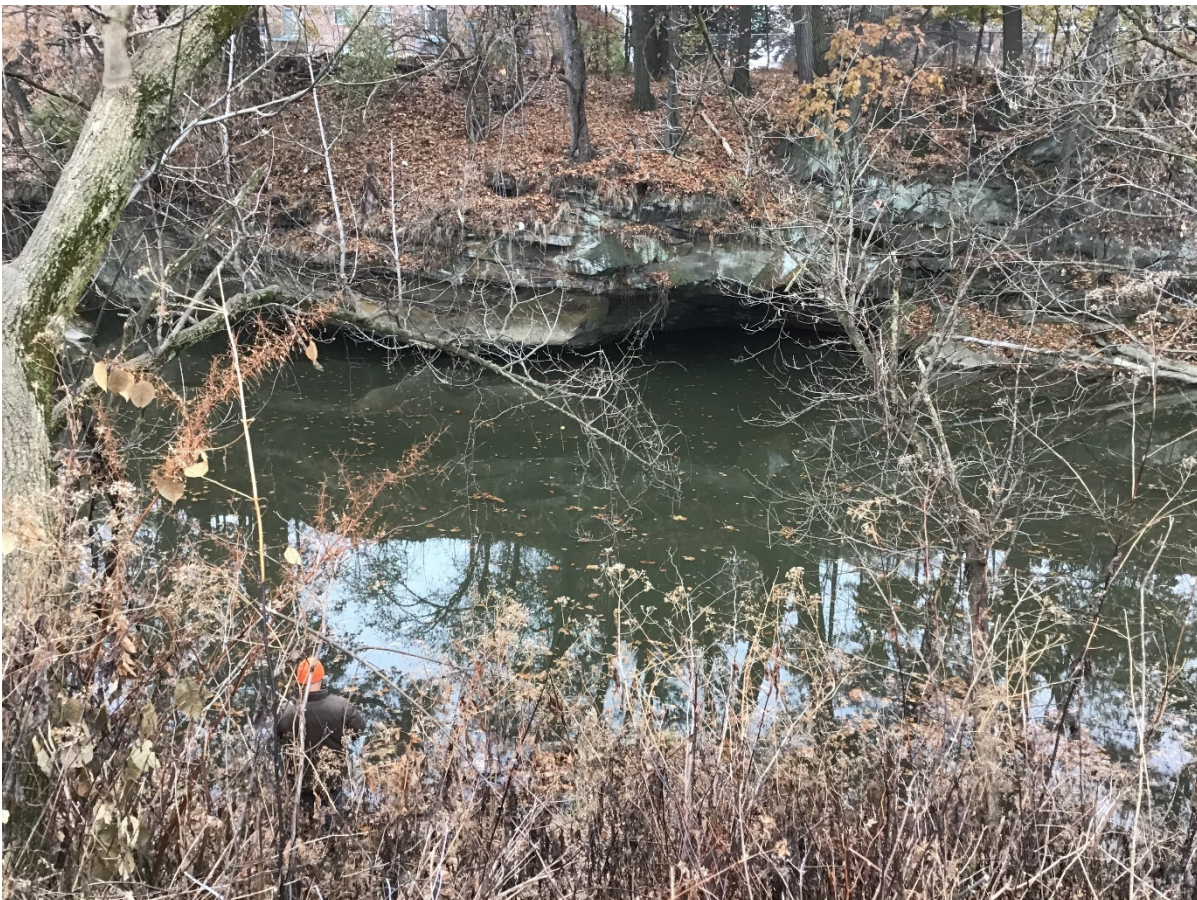
The Black River was inspected by Robert Ford and Pat Steerman. The photograph below shows Robert Ford navigating down the river bank to the Black River:

Robert Ford did not identify any areas where he noted potential groundwater discharges to surface water adjacent to the site. He used an infrared camera to see if thermal contrasts could be detected between groundwater and surface water, but no contrasts were identified using the camera. The temperature difference between groundwater and surface water at the time of inspection was unknown.

OU(s): 1	Issue Category: Monitoring			
	Issue: Potential impacts to Black River from groundwater discharge.			
	Recommendation: Identify where groundwater discharges are occurring and collect samples of surface water, sediment, and pore water for analysis. Update ecological risk assessment as needed based on newly collected data.			
Affect Current Protectiveness	Affect Future Protectiveness	Party Responsible	Oversight Party	Milestone Date
No	Yes	PRP	EPA/State	12/31/2021

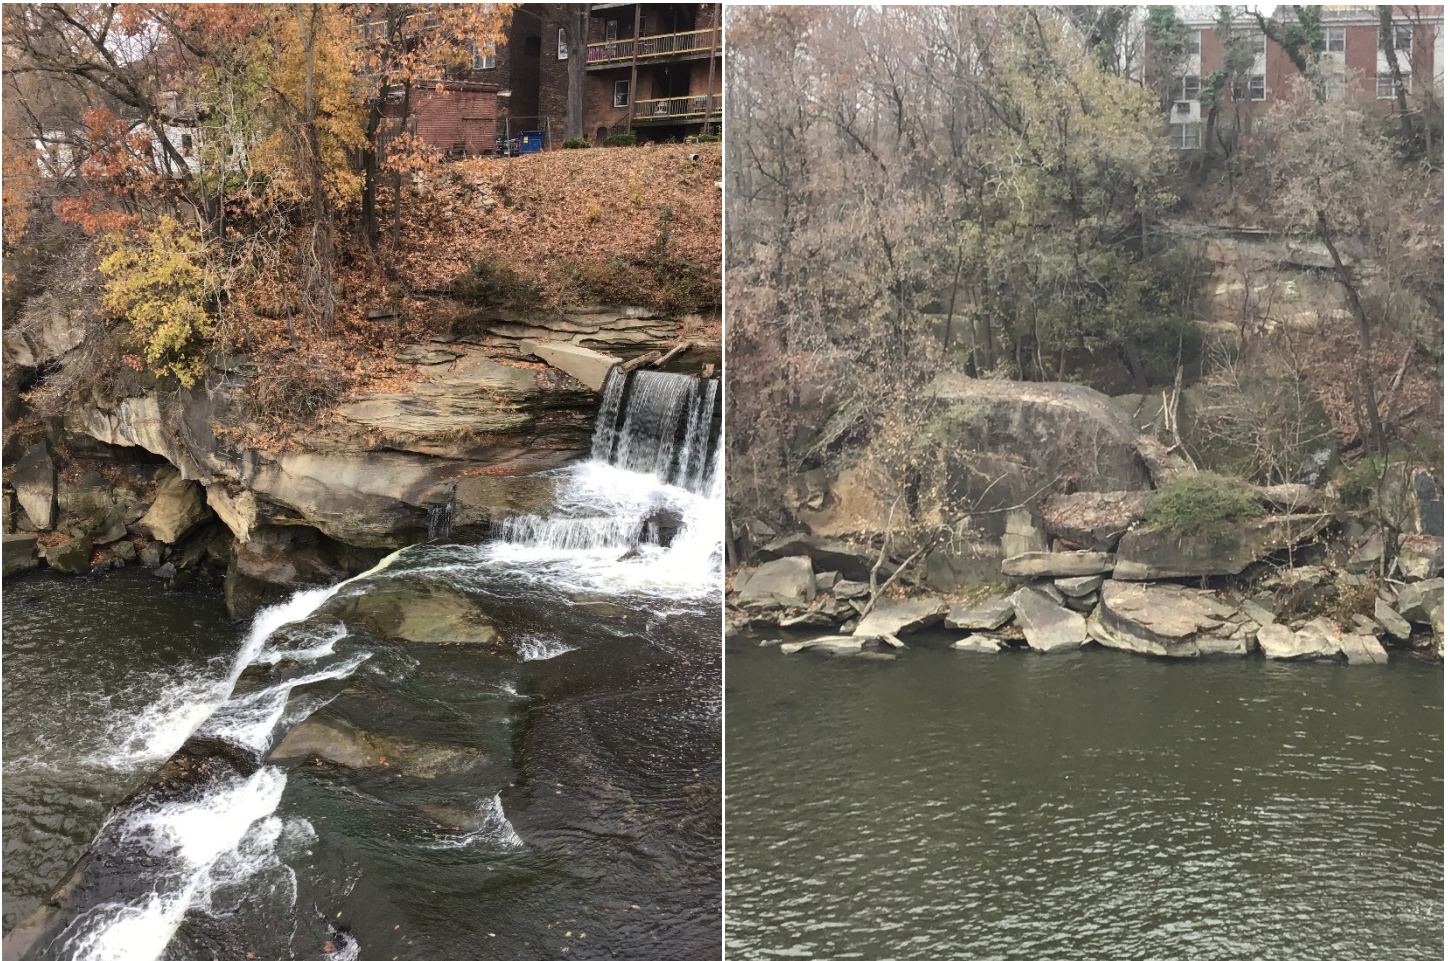
To gain perspective on the geology and other controls of surface water flow, a park adjacent to the river near the site was visited. Fractured bedrock predominates the geology adjacent to the river, and water levels are controlled by two dams. A picture of one of the two dams is shown below.
